The Locomotive

THE HARTFORD STEAM BOILER INSPECTION AND INSURANCE CO.

INDEX TO VOL. 42—1938-1939

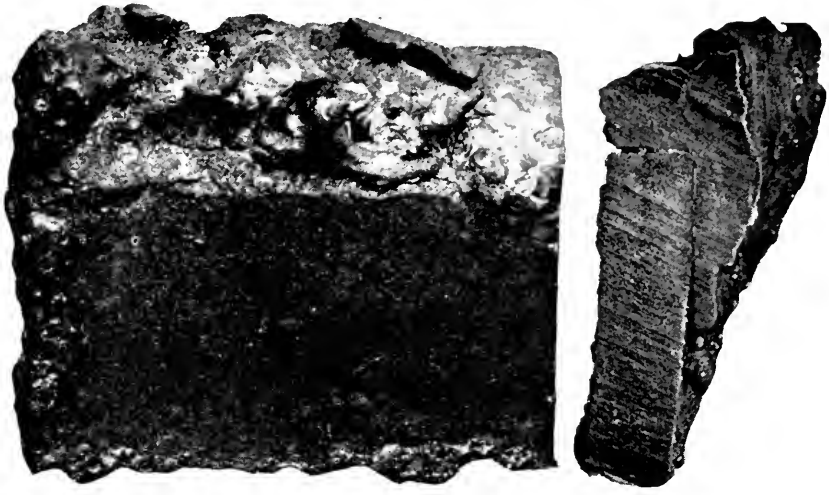
Figure 1. An example of uncontrolled welding. Parts of a 36" x 24" patch on a high pressure boiler are shown. The patch was welded flush with the shell plate and there was very little fusion. How little may easily be ascertained from the photograph at the right showing the cross section of the seam.

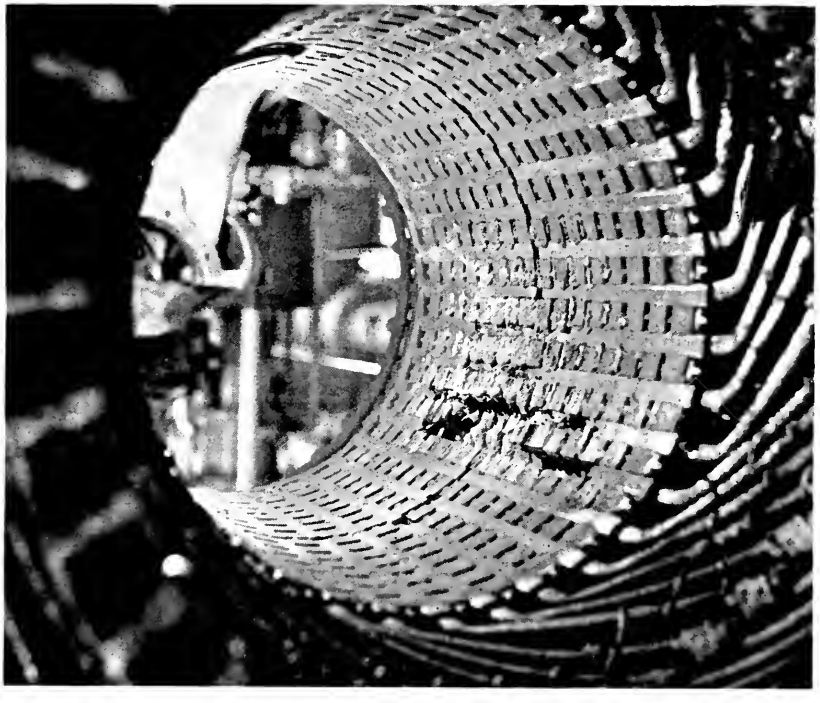
Stator burnout caused by short circuit in a cable.

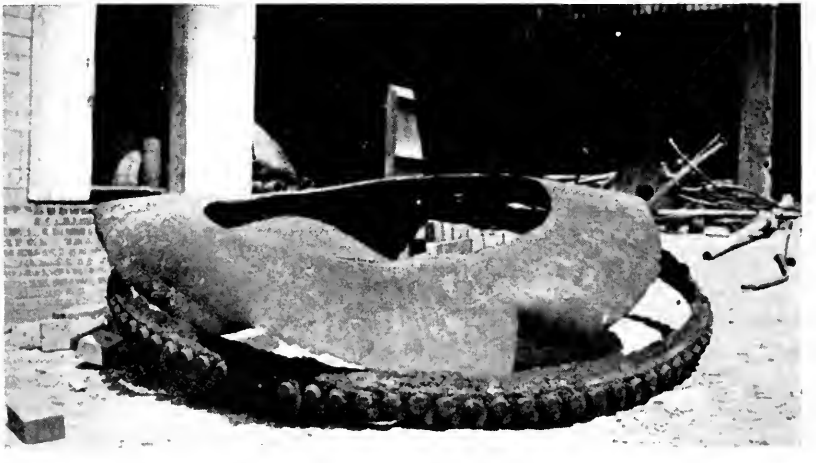
The top head of this tank had become so thinned that it ruptured at an operating pressure of about 72 lbs. The initial tear spread around

Head and seam of rendering tank which exploded after serious thinning because of external corrosion

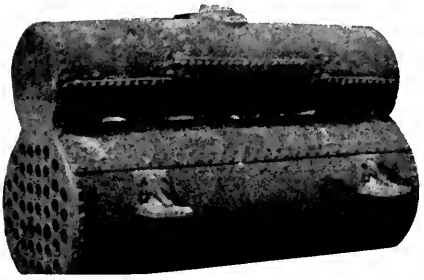
The boiler illustrated on this page was recently retired from service at a Maine laundry after about 60 years of operation. It was built in 1876, and is of interest chiefly with respect to its now obsolete construction details, and long life. The lower drum is 34" in diameter and is crowded with fire tubes. The upper drum is 20" in diameter with a 12" manhole in the head away from the reader. It is interesting that the lower drum, which is 7' 6" long, is of one course with a double-riveted lap seam, while the steam drum is in three courses of single-riveted lap construction. Heads are flat. The boiler was operated at 60 lb pressure. Dimensions secured included the following: Shell plate thickness ¼", diameter of rivet holes 11/16", pitch in the upper drum 2", in lower drum 3", head thickness ⅜".

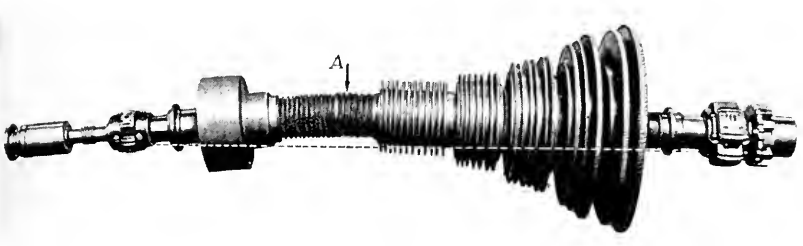
Figure 1—The photograph was purposely distorted to make clear how the shaft was bent and just where heat was applied. The distortion of the shaft is, of course, absurdly exaggerated.

was then applied at "A" (Figure 1) on the top of the spindle (the high side) by means of two oxy-acetylene torches. An asbestos ring was placed around the point that was to be heated, so that a quick heat could be obtained at that location. As soon as the heat was applied at the top, that side of the spindle began to expand and to rise, so that the bow in the spindle was even greater than before the heat was applied. This was seen on the dial indicator, which immediately began to show a plus reading. For the various heats, the torches were applied for periods ranging from 20 to 90 seconds which caused the indicator to show a maximum plus reading of 70 mils for the longest heat, but the best results were obtained by using a heat that raised the spindle only about 30 mils at each heating. As soon as the torches were removed and the top of the spindle began to contract, the drop of the spindle was rapid at first and then more gradual until the indicator again read zero within ten minutes' time. With further cooling of the spindle, the indicator began to show a minus reading until from minus 4 to minus 12 mils for each application was secured after 30 minutes of cooling. This

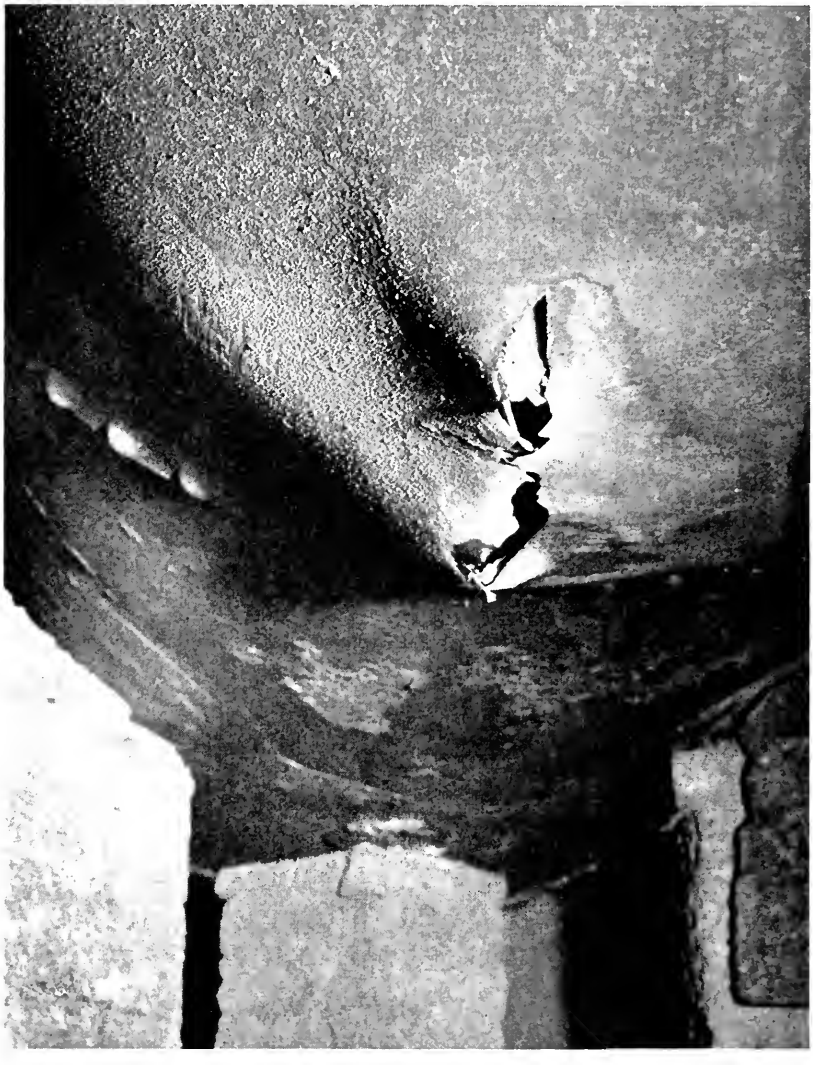
Figure 1. A serious rupture caused by over-heating.

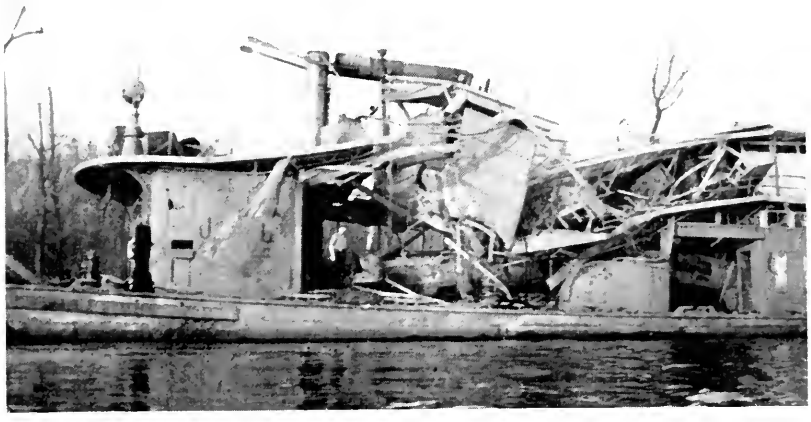
The cause of this accident was not immediately determinable because part of the boiler was blown into the river. Later the failing part of the shell was found. It revealed the probable cause of the accident to be over-heating and bulging of the second course of the boiler because of an accumulation of mud and scale.

As the section of plate which failed went overboard, it took with it the two firemen, who were on the deck. The rest of the boiler moved aft about 23 feet so that the rear head struck a condenser and an evaporator, damaging both. The smokestack and breeching which served the exploded boiler and another mounted with it were damaged, and the other boiler was badly dented. Living quarters of the crew and

Figure 1—Results of an explosion because of over-heating.

captain above the boiler room were wrecked, as is shown in the photograph, and there was other damage to the pilot house, coal bunkers, pipes and machinery.

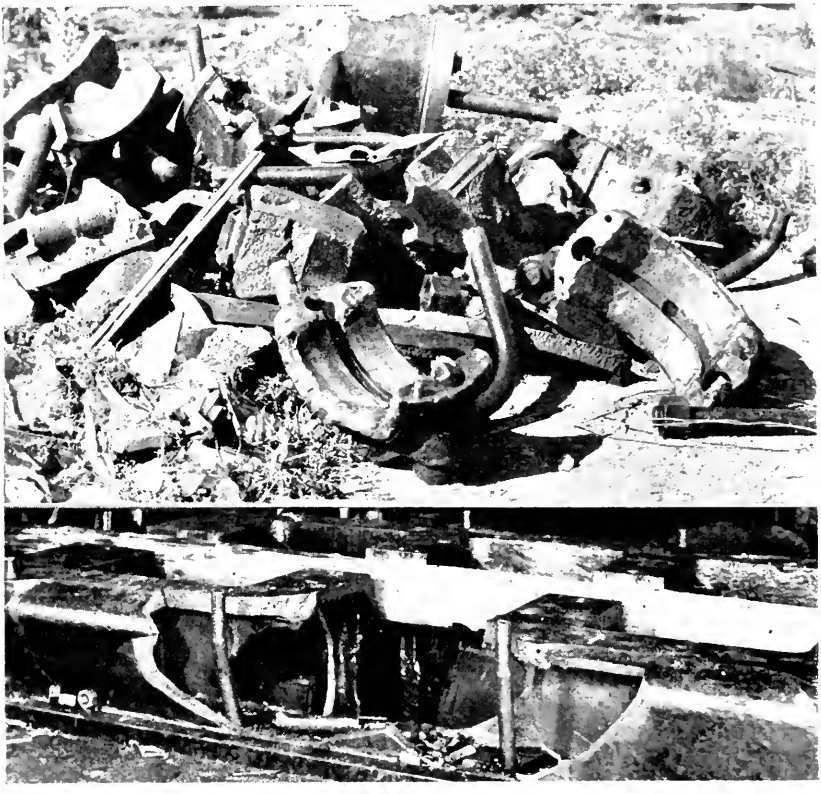
The over-speeding caused the operators to shut off the regular fuel supply, but a combustible mixture was entering the scavenging inlet

Figure 1—Above—This pile of metal contains parts of a 600 hp Diesel engine which was destroyed in a second or two when it over-speeded. Below—One side of the engine base after the broken engine parts passed through it.

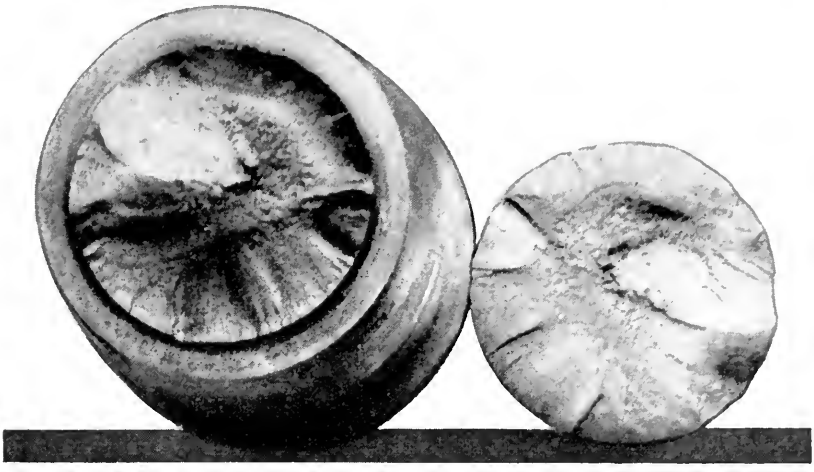
A shaft failure that occurred on a 300 hp wound rotor motor driving rubber rolls through a magnetic clutch and reduction gears. This failure occurred at the inboard end of the journal and at a location not ordinarily accessible for inspection. Vibration developed suddenly and the machine was taken out of service before breakage actually occurred. The shaft was broken in order to study the character of the crack, which was attributed to misalignment or improper adjustment of parts at some prior time.

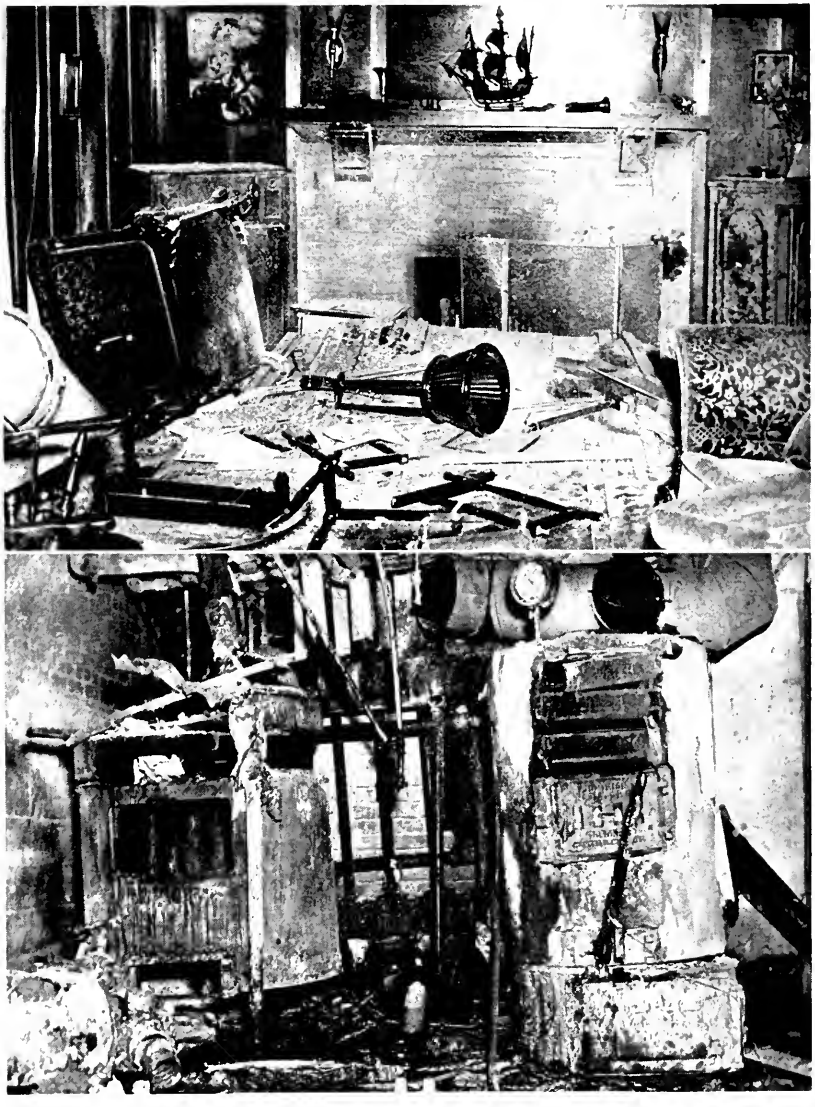
The above views show part of the damage caused by the recent explosion of an oil-fired hot water heating boiler in a residence. Occurring in the boiler at the left, the explosion blew the top section into the floor above, damaging the living room as shown. The foundation of the

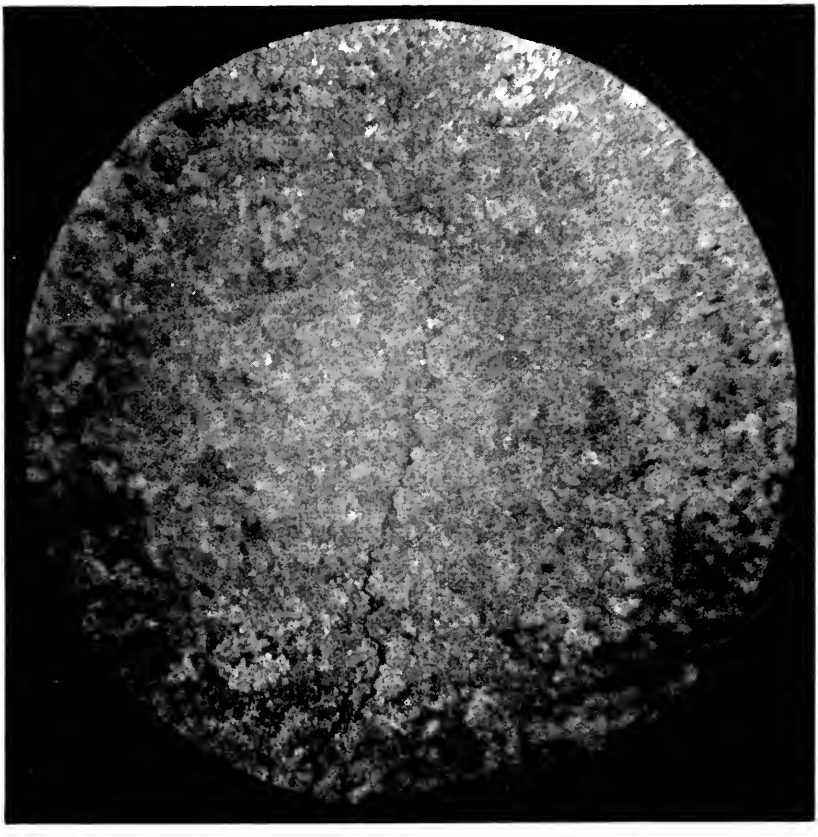
Figure 1—An embrittlement defect at about 100 magnifications. This is what the eye sees when using the regular Hartford Steam Boiler magniscope on a highly polished wall surface of a rivet hole.

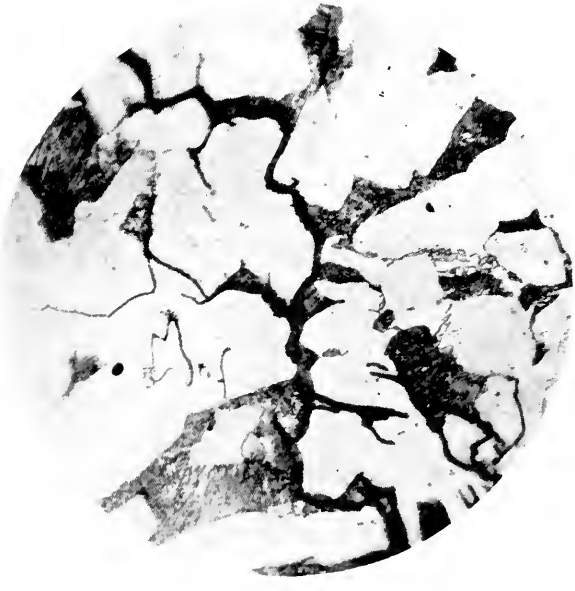
Figure 3—Embrittlement at 500 magnifications. This defect developed in a boiler under ordinary operating conditions. The characteristic intercrystalline path of the disintegration is clearly shown and is directly similar to the disintegration produced in the laboratory and shown in Figure 2.

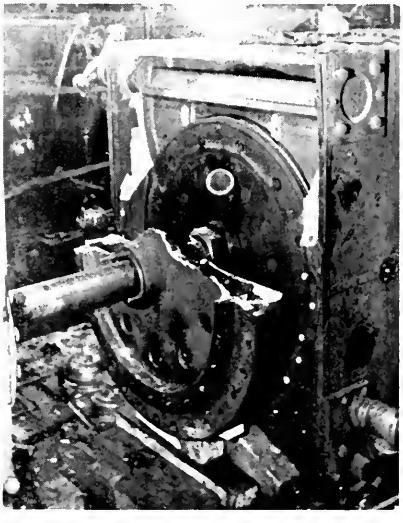
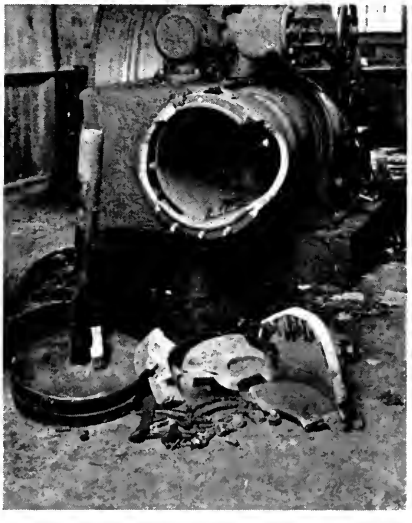
Figure 2—(Left) the result of a connecting rod crack. Figure 3—(Right) the result of a failure in the threads on the piston rod just inside the crosshead.

The frequency of cracks in crossheads has brought a recommendation for the replacement of cast iron crossheads with crossheads of steel. The reason for this lies in certain inherent properties of the two metals. Cast iron has very little elasticity or ductility so that the shocks which inevitably occur on a reciprocating engine will more readily start a crack in a cast iron crosshead.

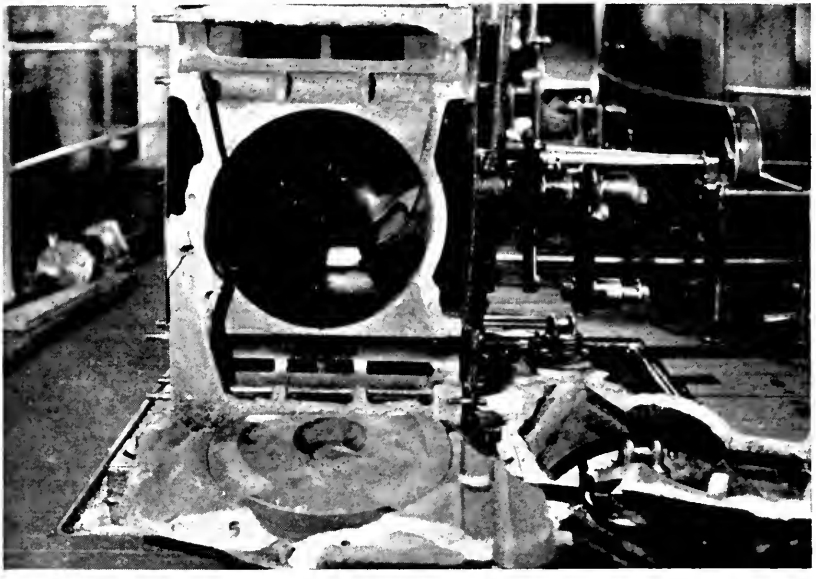
Figure 4—An accident attributed to the failure of follower bolts.

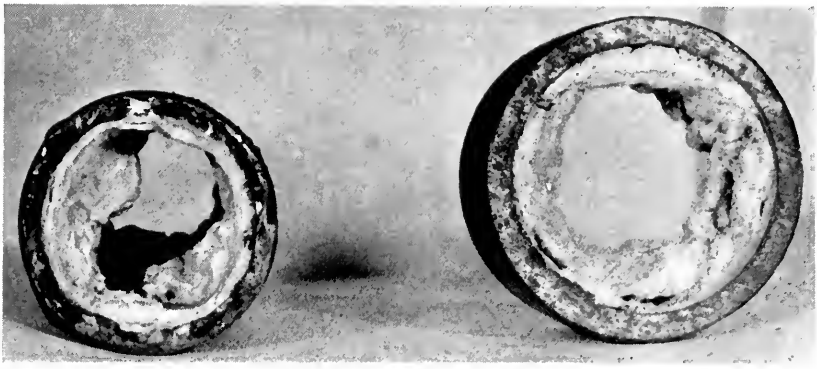
Figure 2 shows two superheater tubes from boilers in widely separated plants and owned by different companies. Both of these tubes,

Figure 2—Superheater tubes from two boilers in widely separated parts of the country. Carry-over of solids in the steam rapidly builds up such deposits.

from affected sections of the superheaters, contain a hard scale which in some of the tubes nearly filled the steam space. These deposits occurred in boilers operated only four or five weeks and were from wet steam carried over from the drums. Impurities in the feedwater were the primary cause, but other factors such as the height of the water in the boiler, the arrangement of steam scrubbers, circulation and gas passes were contributory.

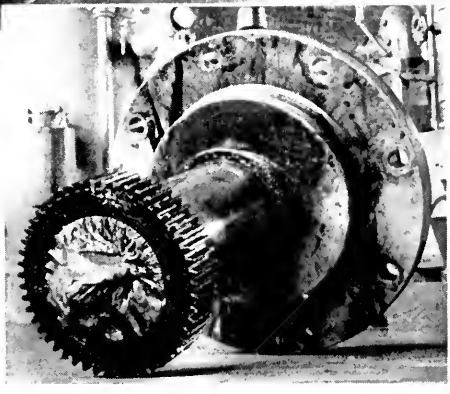
Engine Crankshaft Failure

THE breakage of this crankshaft in a 140 hp Diesel engine used at a New England ice plant was attributed chiefly to torsional vibration. Starting around the circumference of the shaft under a fillet at a web, cracks progressed into the shaft and so weakened it that it broke after about one year's service. The failure, which was roughly conical in shape, is typical of torsional vibration breaks with their radial failure lines. In this installation the timing gear was immediately adjacent to the break. Beyond it (to the left in the top picture) was a main bearing and outside this a 5,700 lb flywheel. It is felt that the weight of the wheel added to the stress at the point of failure and hastened the break. The direct damage loss, which amounted to nearly $4,000, was covered by Hartford Steam Boiler.

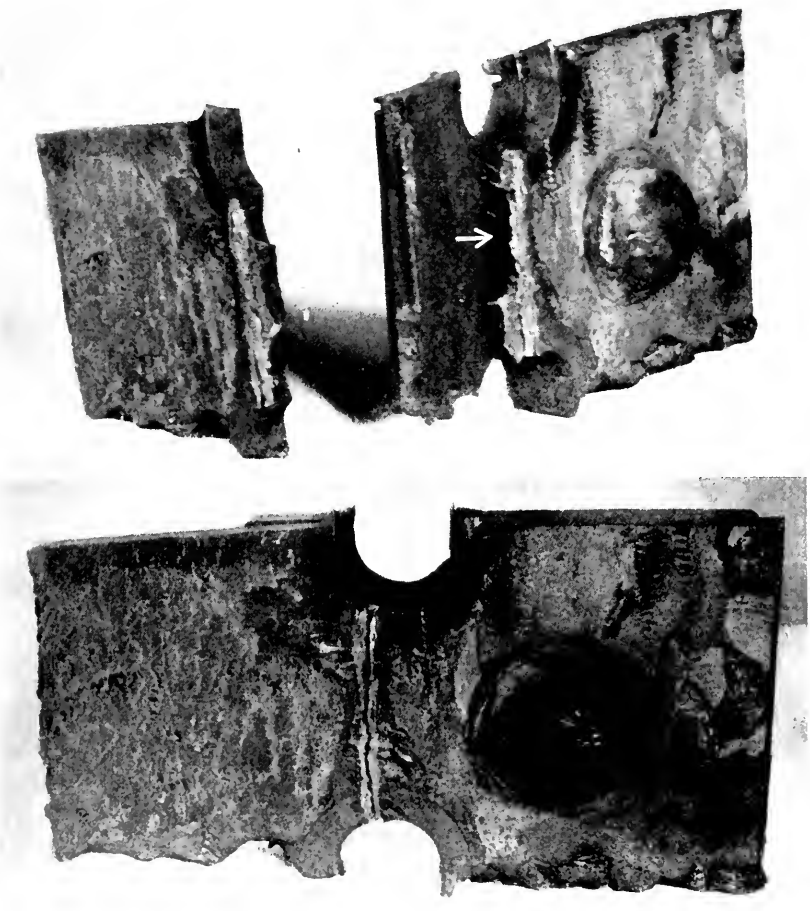
Figure 2—A fully developed embrittlement defect in metal from one of the steamer's boilers. The lower picture shows the rivet hole to rivet hole direction of the disintegration. The top picture is of the same pieces of metal as the lower, the dark areas in the break illustrating the development of the embrittlement (see arrows).

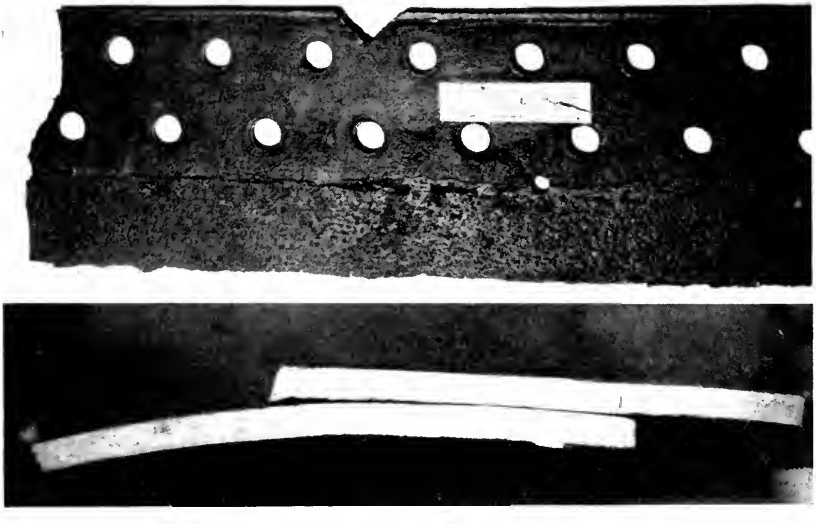
Figure 5—Top and end views of a typical lap seam crack. Notice that this defect is on the opposite side of the seam from the failures shown in Figures 1, 3, and 4. The picture at the upper right shows a lap seam failure under hydrostatic test.

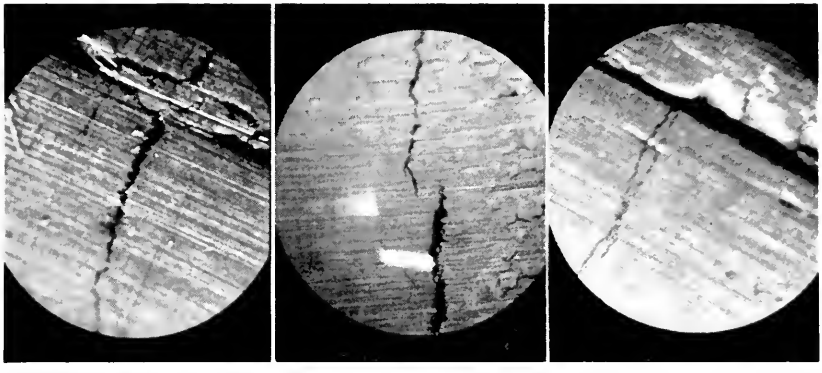
Figure 6—Embrittlement defects from Boilers Nos. 1, 2 and 3 (from left to right) as seen in rivet holes through the Hartford Steam Boiler magniscope.

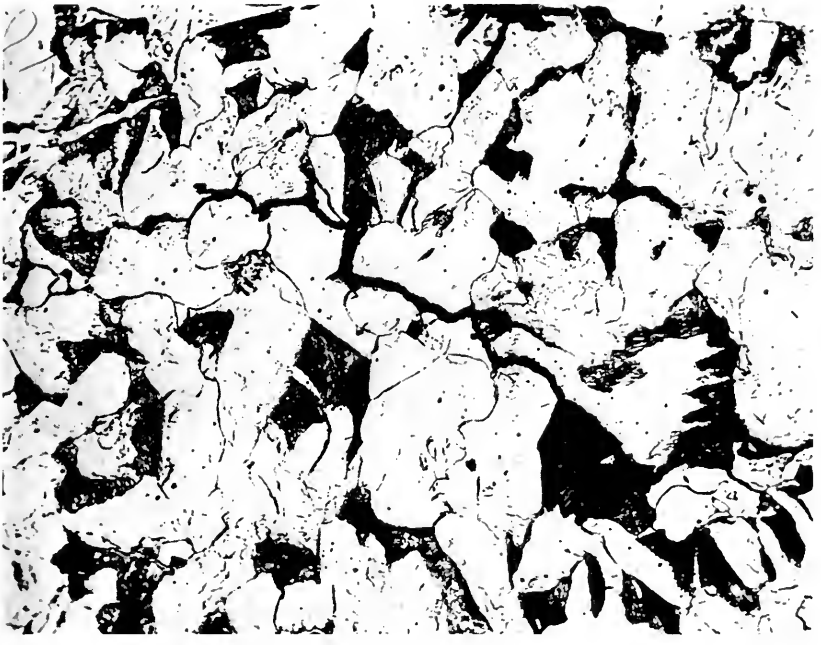
Figure 8—Embrittlement at 500 magnifications in a section of plate from Boiler No. 1.

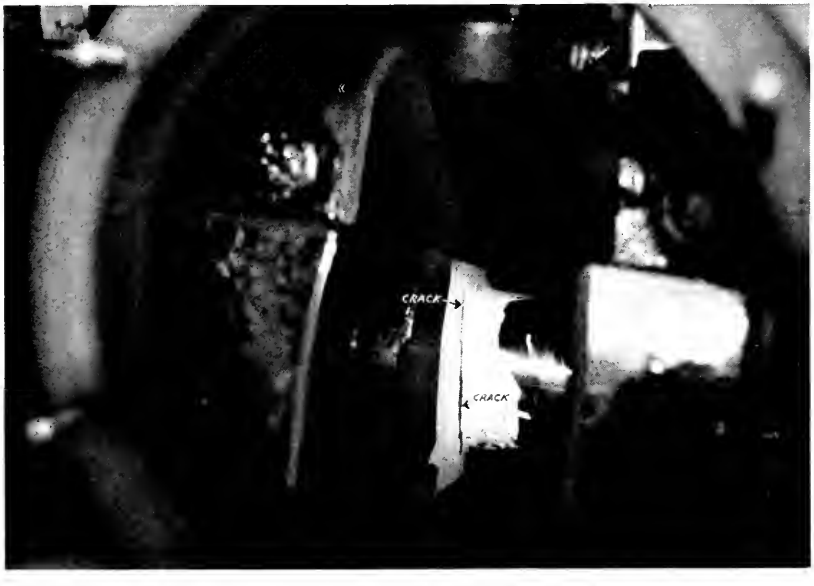
Figure 1—Crack in the fillet of the crankweb and crankpin of a Diesel engine. It was located by means of the whitewash test without dismantling the engine.

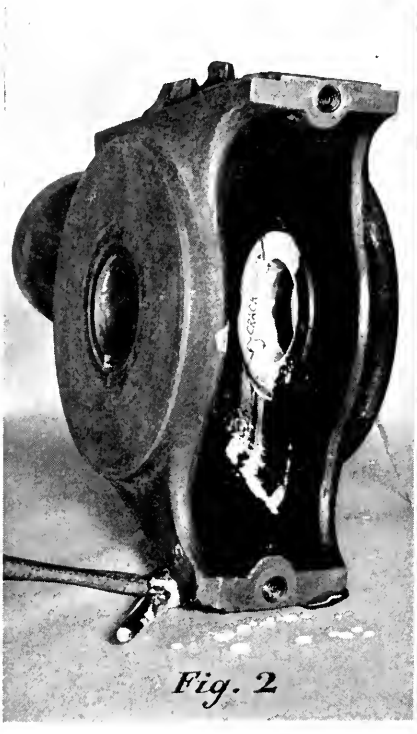
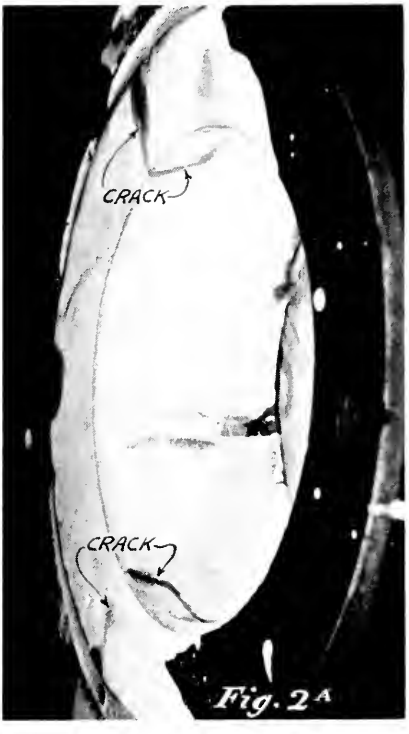
Figures 2 and 2A—Whitewash test showing crack across one of the eyes on the inside of a crosshead.

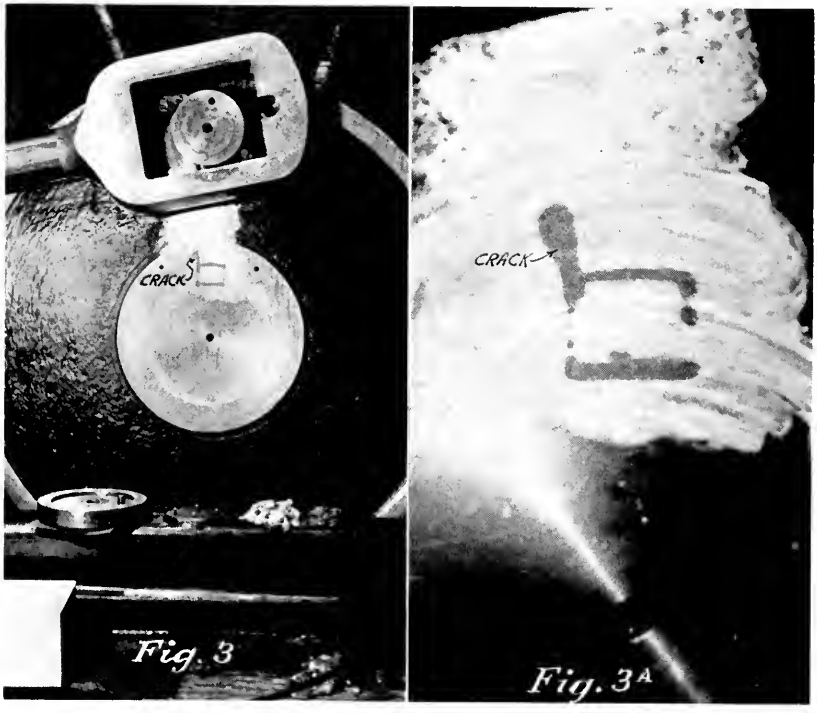
Figures 3 and 3A—A fine crack in the keyway of a steam engine crank. Figure 3A is a magnification of the defect.

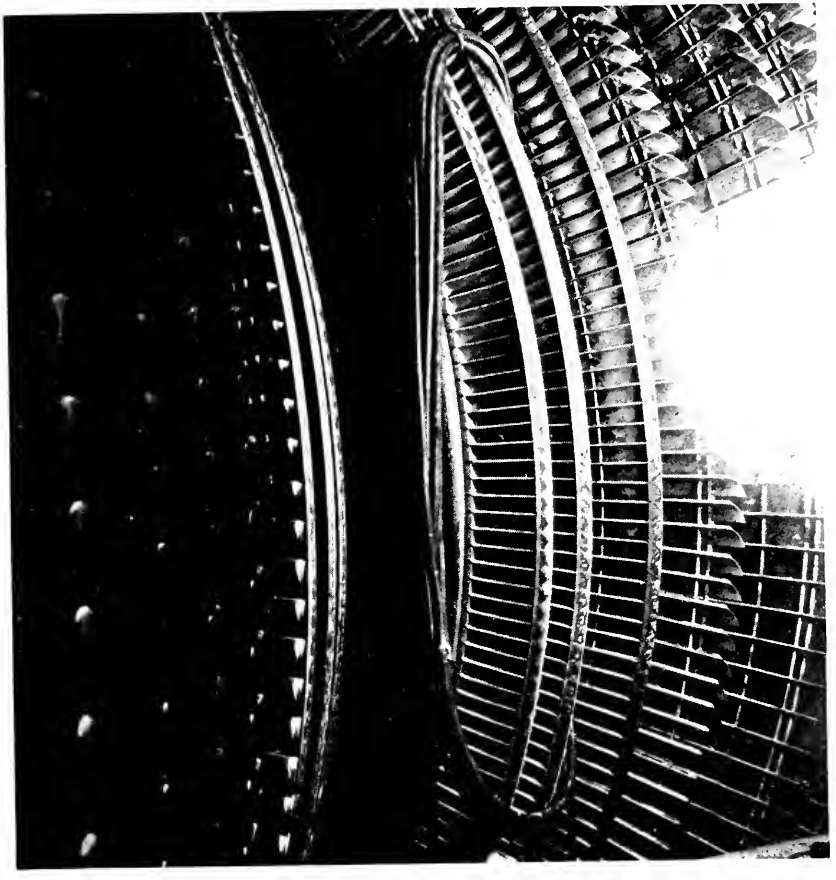
Figure 4—Applying the Magnaflux method of crack detection to steam turbine blading.

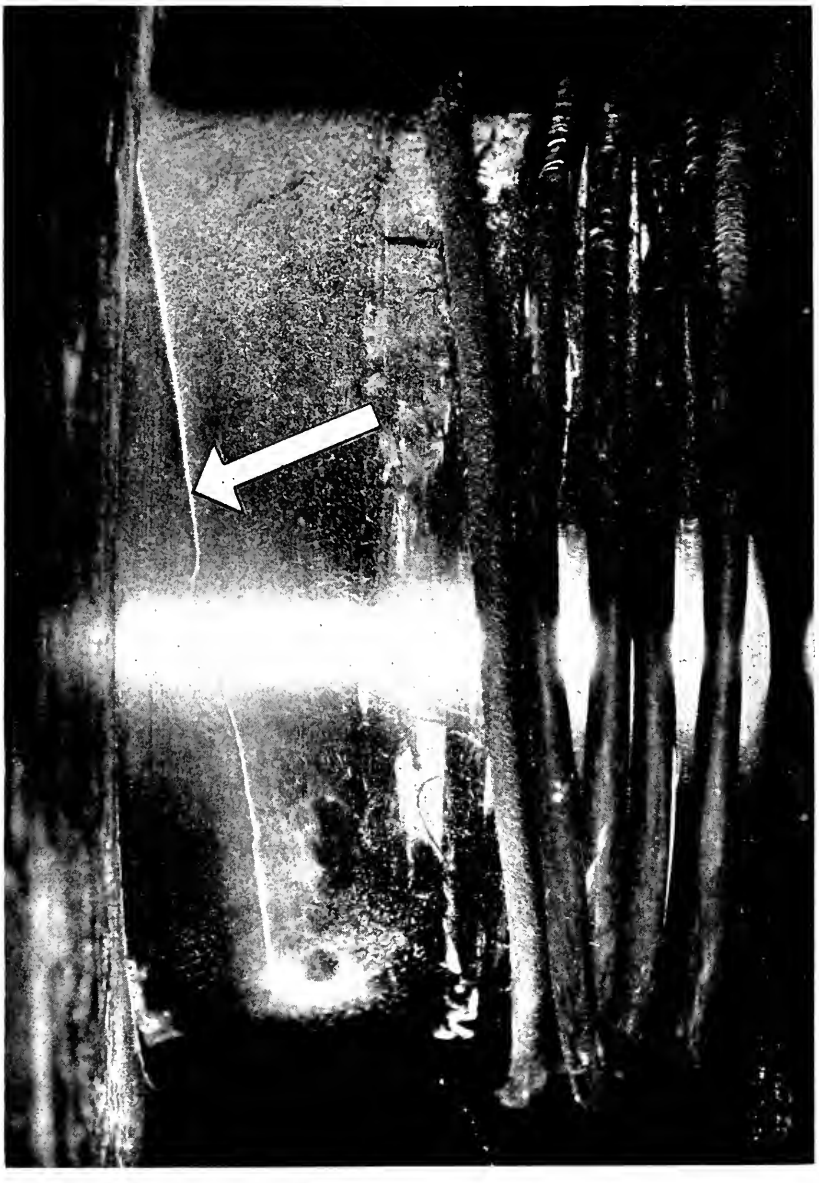
Figure 5—Magnaflux method applied to a shaft to determine the extent of a crack which had been detected by means of the unaided eye. The magnetizing coils are shown at the right.

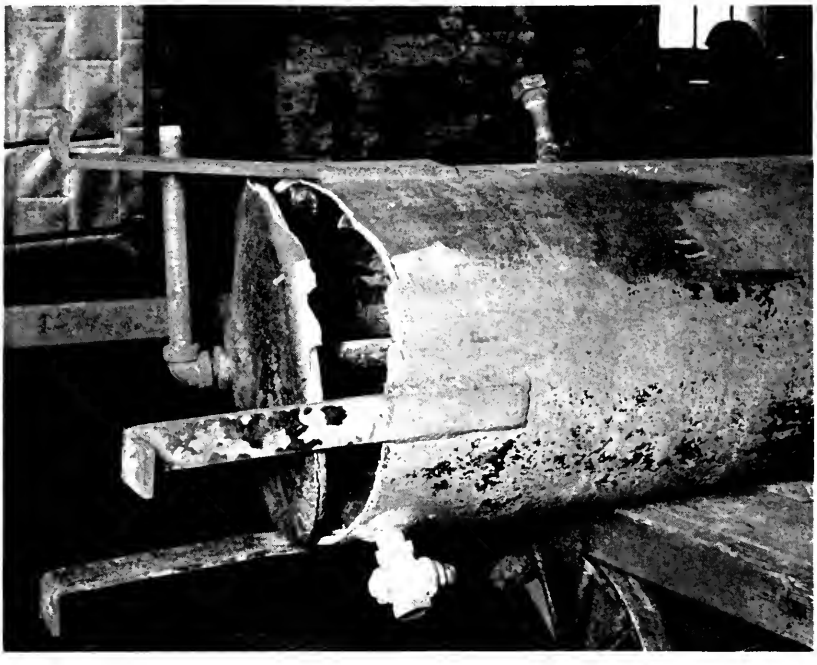
Figure 5—Broken shell of a hydro-pneumatic tank in which the shell had been crimped around the head and welded.

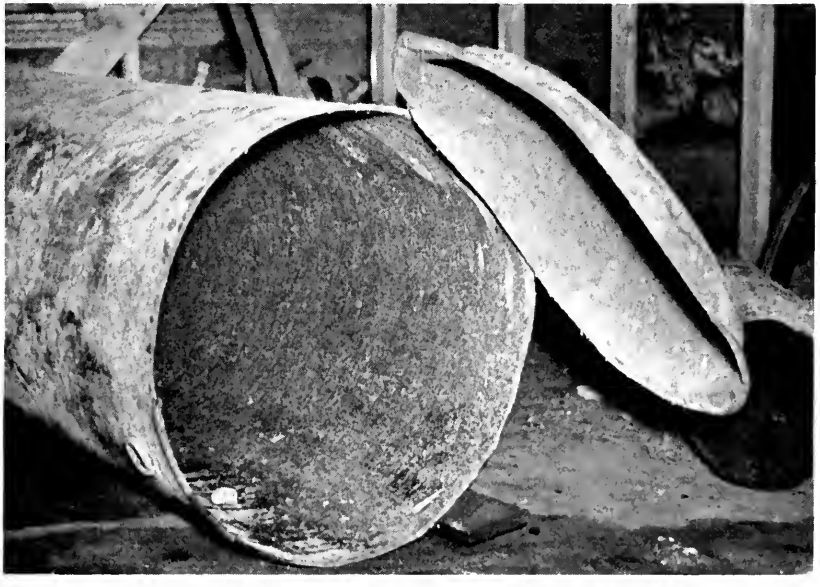
Figure 2—The tank which failed. The reversed minus head is clearly shown.

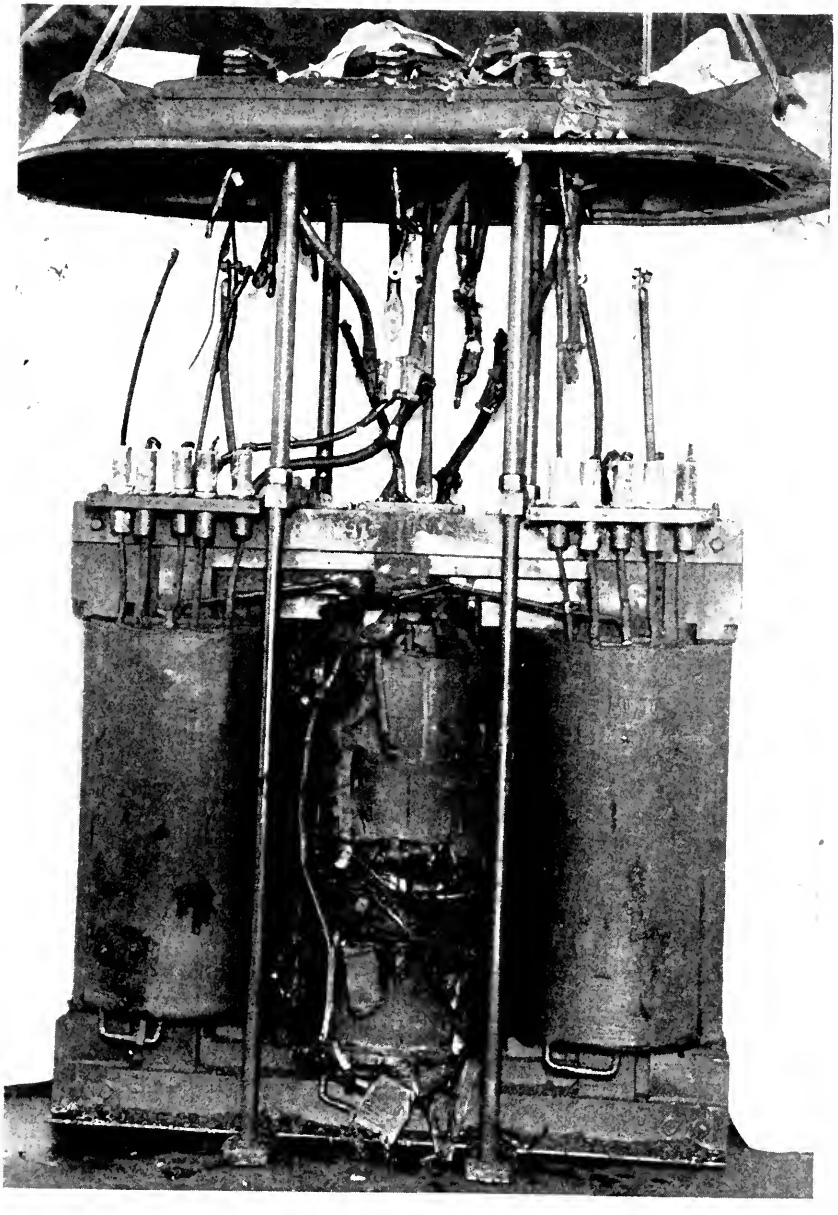
Figure 1—Coils of a 500 kva transformer after a short circuit in the primary windings. The photograph shows the high voltage terminal side of the transformer.

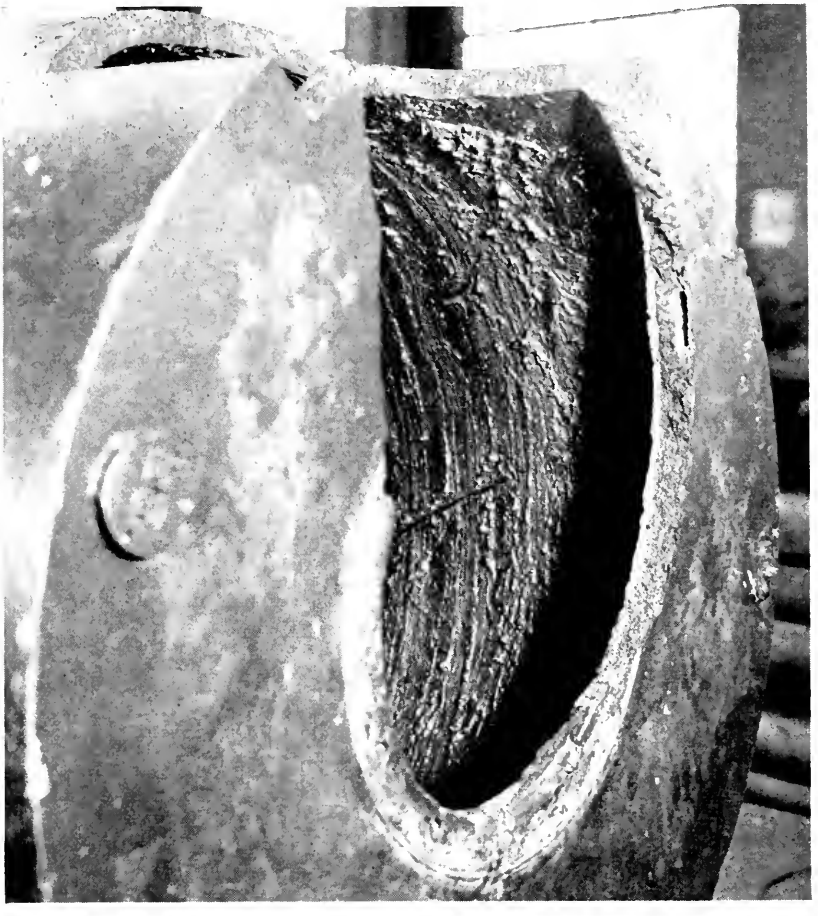
Figure 3—Lard cooler which exploded under normal use because of the failure of a defective casting.

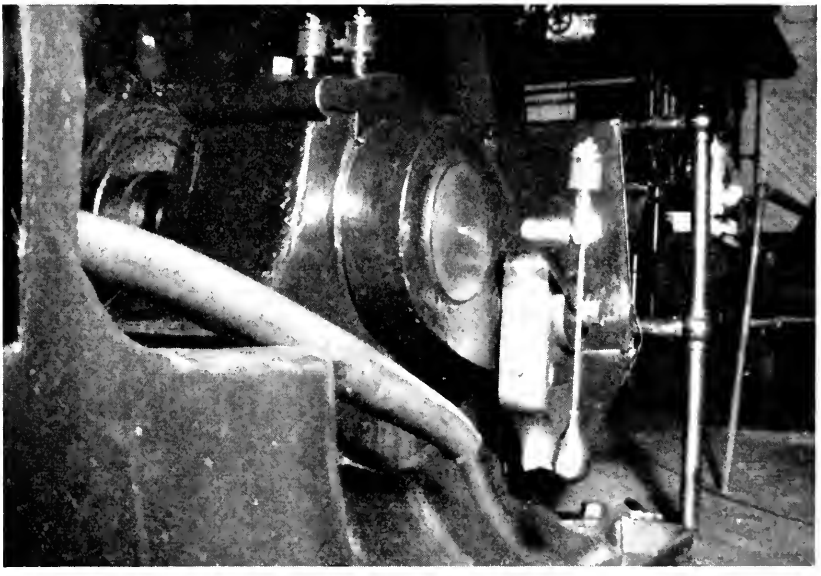
Figure 6—Broken connecting rod of a 150 lb ammonia compressor. The accident was attributed to an attempt to start the compressor 3 times in spite of burned out fuses. The discharge valve had not been opened.

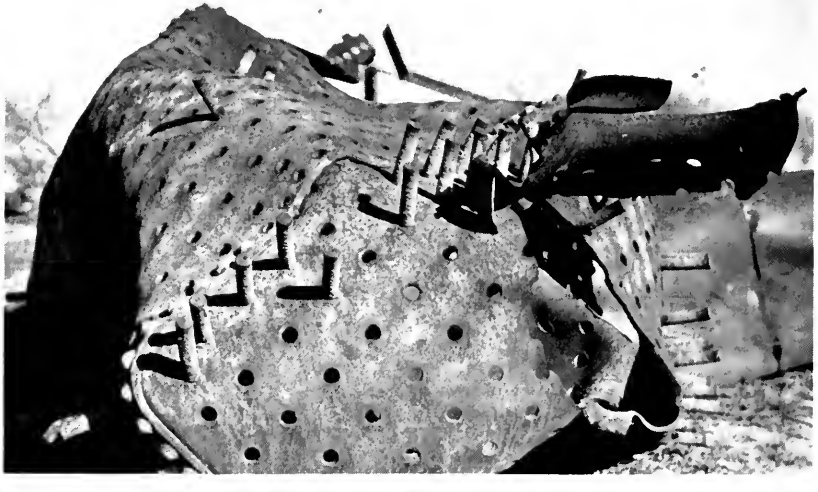
Figure 1—Firebox of a locomotive type boiler in an oil field after its explosion due to low water and over-heating.

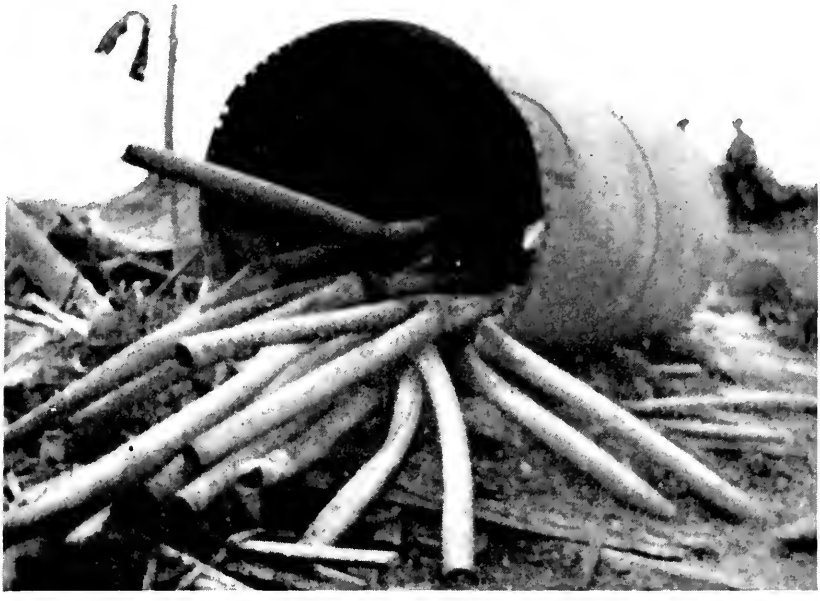
Figure 2—Two courses of a three-course horizontal tubular boiler which exploded because of corrosion.

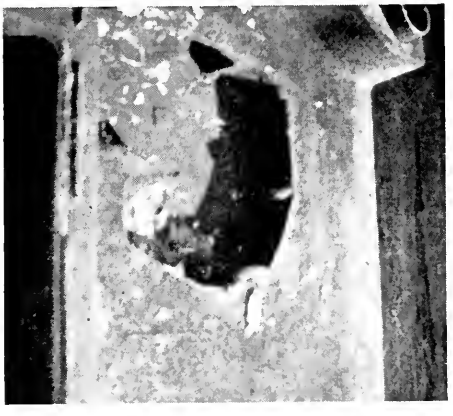
Four hundred fifty persons walked in orderly fashion from an Illinois theater after a cast iron hot water heating boiler exploded beneath the stage. Although the stage was wrecked and some of the debris was blown into the seating floor of the theater, all but two women escaped, and they suffered but minor injuries. The boiler exploded, it was said, because of the non-operation of the relief valve. A piece was blown out of the boiler as shown in Figure 4 and sections were torn apart. It was estimated that the damage was approximately $4,000.

Figure 4—Failing section of a hot water heating boiler in a theater.

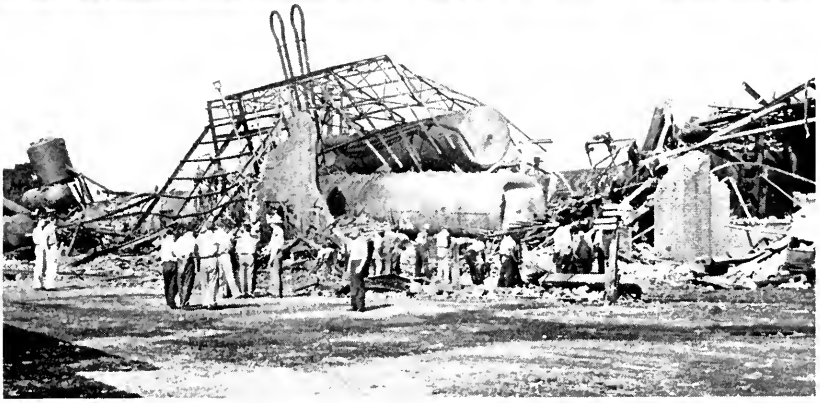
Figure 1—Top page 226—Damage after the explosions of a creosote tank and a water tube boiler at a southern plant.

Figure 2—Center page 226—A tank similar to the upper vessel in the center of the picture exploded. Timbers to be creosoted are placed in the lower cylinder.

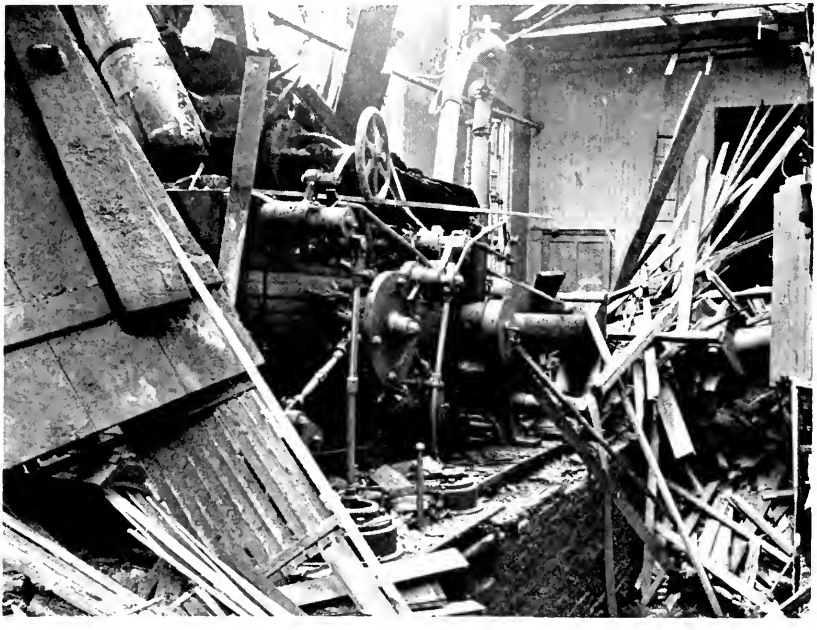
they fell to the floor. An operator who was near the engine was killed. The steam engine was wrecked, and several other machines were damaged because of the over-speed. To reassemble the control devices following an accident of this sort in a search for the cause of the accident is not easy. In this case two factors probably contributed to the failure. One was a breaking governor belt and the other the fact that the safety cams were undoubtedly out of adjustment because, although they were set at the farthest point of adjustment away from the latch arm, they did not prevent the opening of the steam valves with the governor in its lowest position, as they should have done. There was no insurance on the engine.

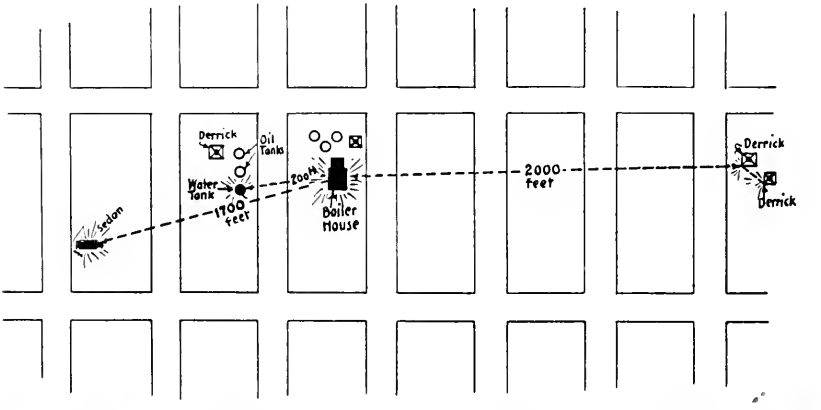
Illustrating the Versatile Marksmanship of an Exploding Boiler!

This diagram represents several sparsely settled city blocks in a western town where oil drilling operations are under way. The explosion of a horizontal tubular boiler early in the year demonstrated more than the terrible force of such failures; it gave evidence of uncanny marksmanship. About 1700 feet away was a small automobile. A piece of the boiler tubing crashed into it. About 2000 feet in the opposite direction was an oil derrick. The door of the boiler not only hit it but ricocheted into another derrick nearby. About 200 feet away was a water tank, an easier mark, into which smashed the shell of the boiler, crushing the tank nicely. A partially wrecked boiler house, an automobile buried in debris beside it, and bricks scattered like bird shot in all directions were other details. The accident was attributed to mud choked safety valves and over-pressure.

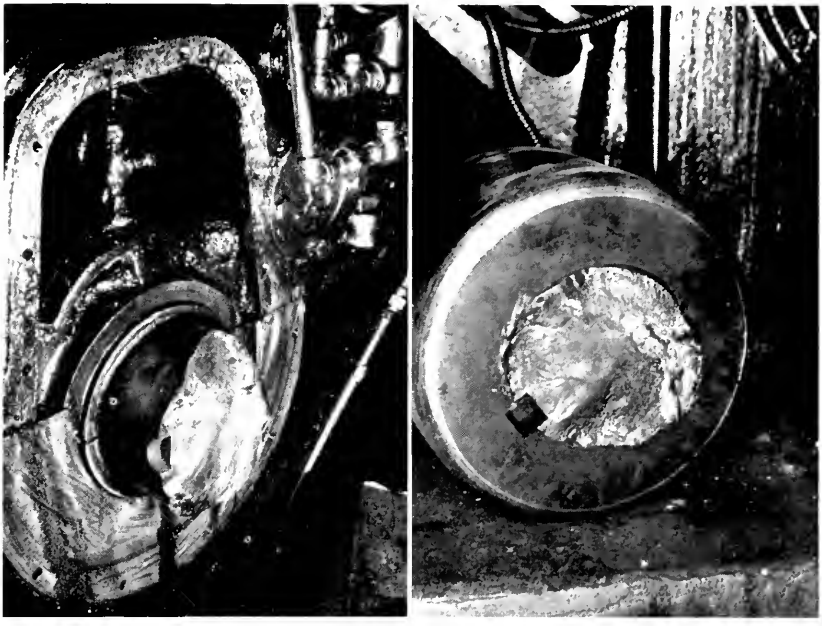
A good example of a shaft break because of torsional vibration is illustrated by the two photographs on this page showing the faces of the break, which started at the keyway and progressed about 40 per cent of the way through the shaft before the final separation occurred. The picture at the left shows the engine end of the shaft and that at the right the coupling end.

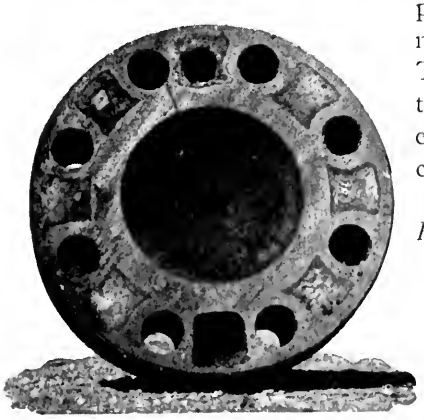
Figure 1—Diesel cylinder-head completely choked with scale. The faulty water condition in connection with an open cooling system caused repeated failure of the cylinder-heads on this engine.

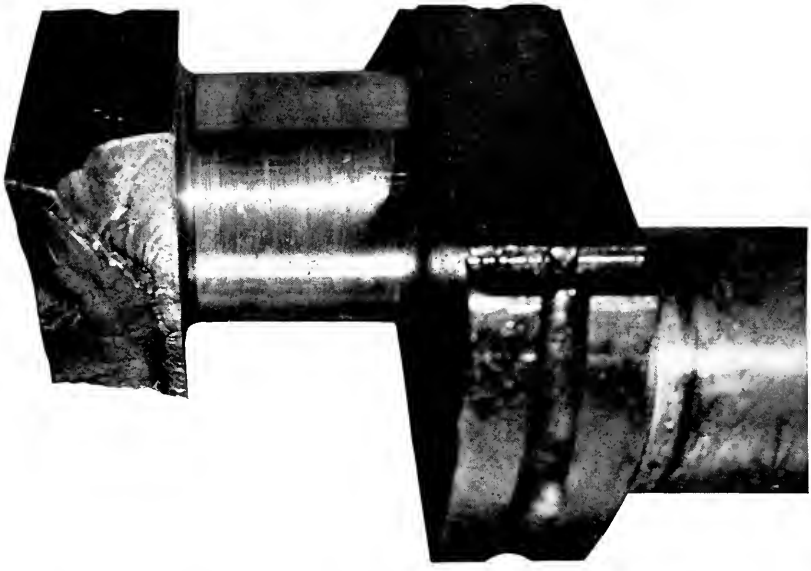
Figure 2—Crank distortion caused by bearing misalignment resulted in the breaking of this crankshaft. The fatigue cracks started in the fillet on the journal side of the crankweb.
